PROTECTION OF AIRCRAFT FLUID SYSTEMS

LTV Aerospace Corporation

TECHNICAL REPORT AFML-TR-68-125

May 1968

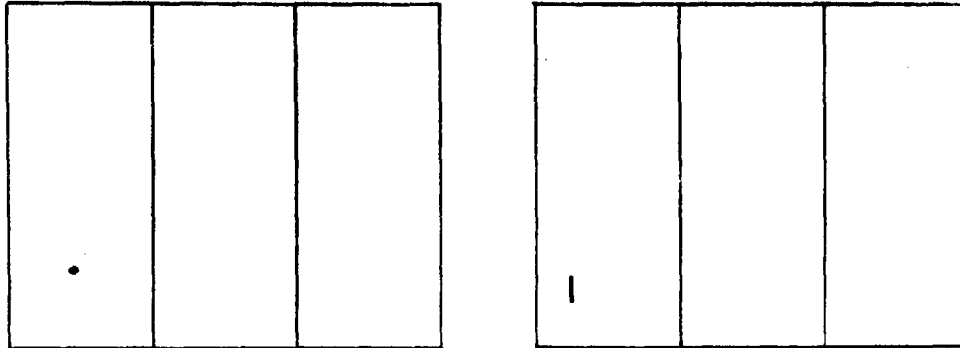
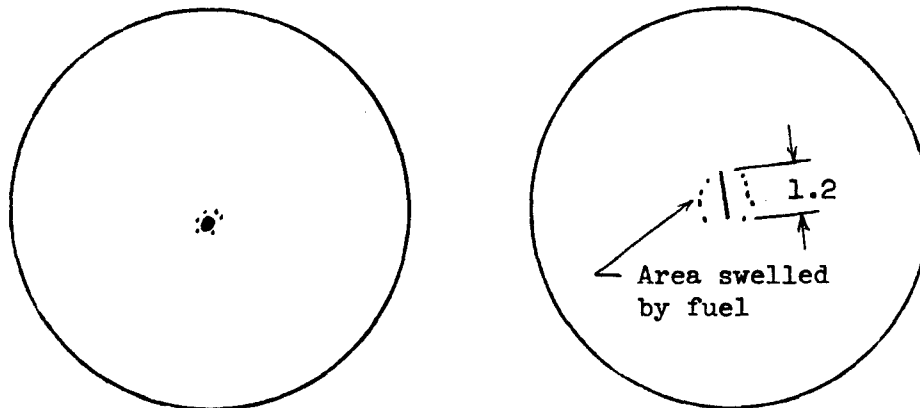
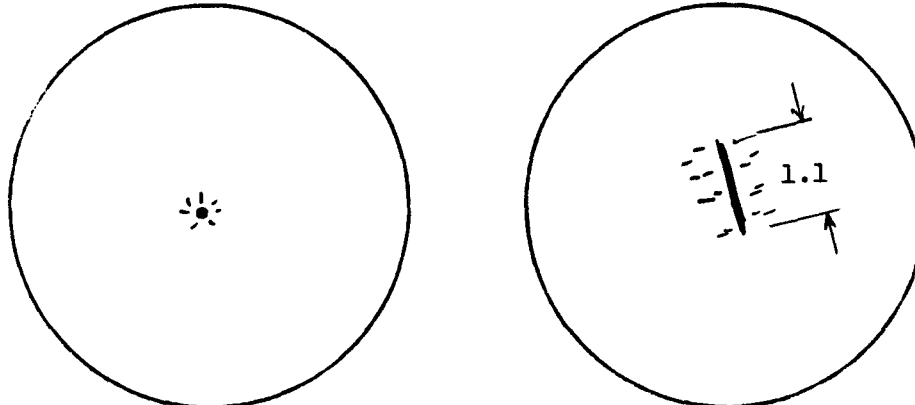
Backing board frayed but the self-sealing material sealed instantly with no trace of fuel leakage.

Backing board frayed and the self-sealing material wound leaked at approx. 1/8 gal/min rate until the pressure was reduced to 0. When repressurized the wound would partially open.

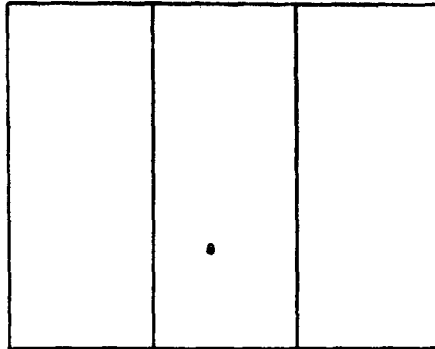
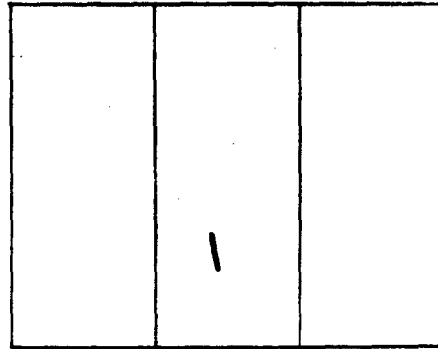
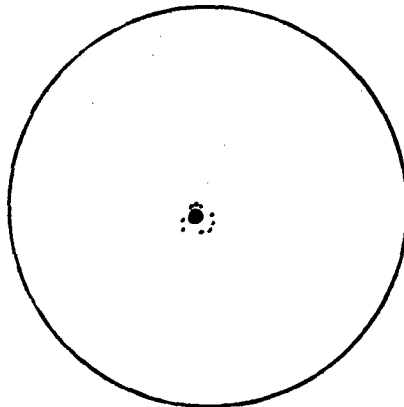
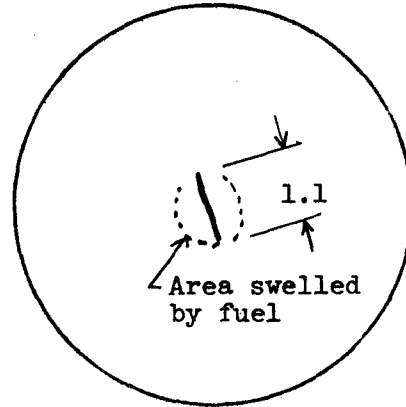
Backing board frayed some. Self-sealing sealed instantly with no trace of fuel leaking.

Backing board frayed and self sealing leaked at a rate of 500 ml/min constant until pressure was released.

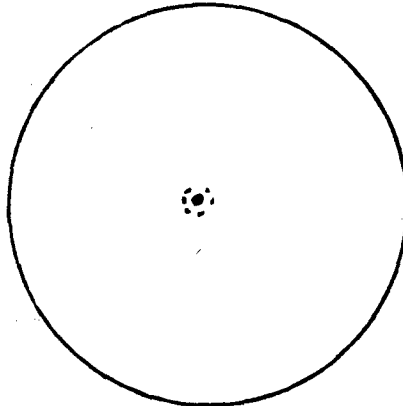
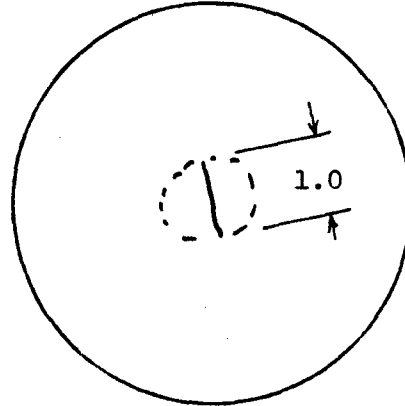
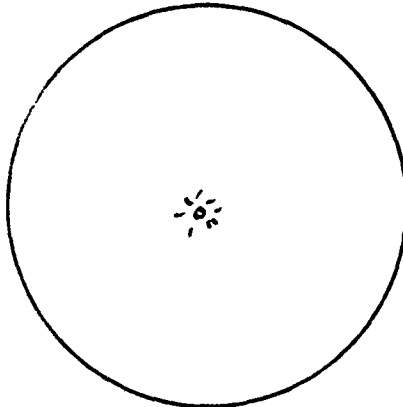
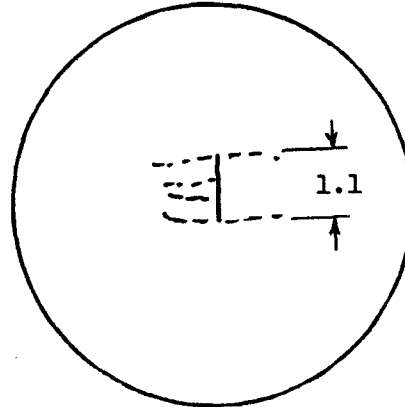
Backing board frayed and cored. Sealing material cored slightly.  
No seal affected. Leaked at Constant Rate of 100/ml per minute at 0 pressure.  
FAILURE.

Note: The Projectile lost its nose before hitting the entrance. The nose hit the jig and splattered thus causing other damage to the entrance side with one penetration from shrapnel. Wound sealed though.

On disassembly the self sealing material was found to be cracked where it was impacted by the projectile.

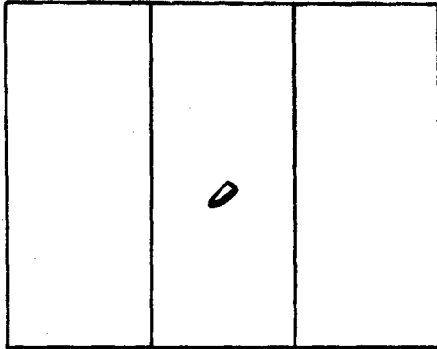
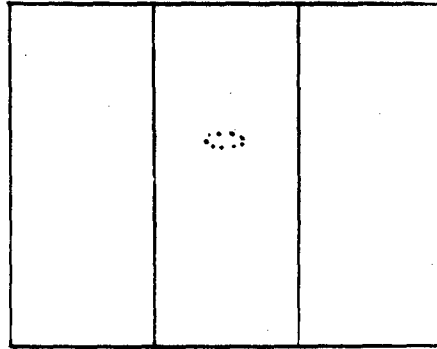
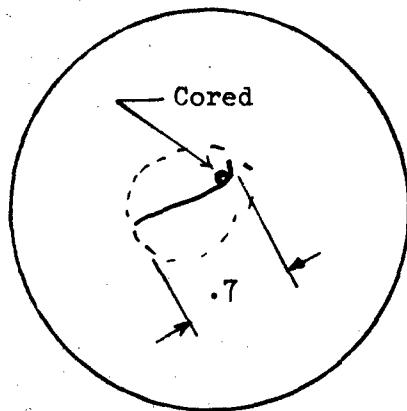
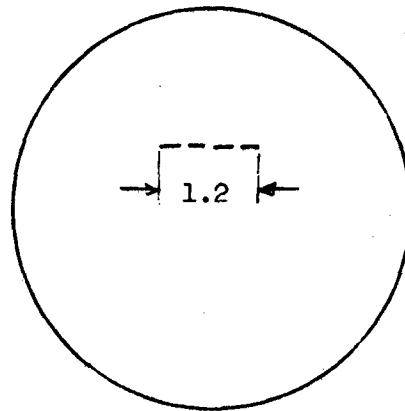
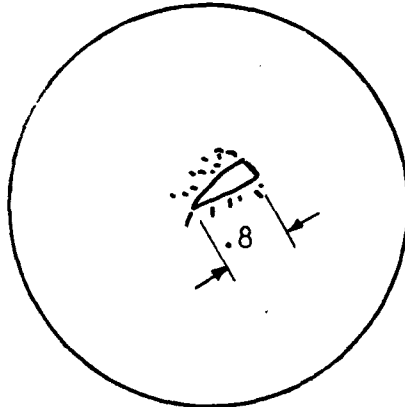
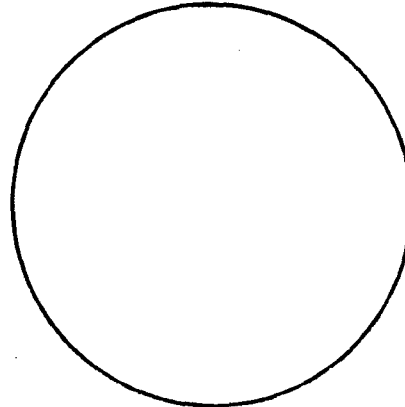
BLOCK NUMBER B 9  
ROUND NUMBER T 22

The sealant material was not damaged on the entrance, but on the exit it was slit .8 inches long and required 5 minutes to obtain a full seal. Total leakage was 100 ml. However, when pressurized to 2 PSIG the wound opened and continued to leak at a rate of approximately 100 ml/minutes.

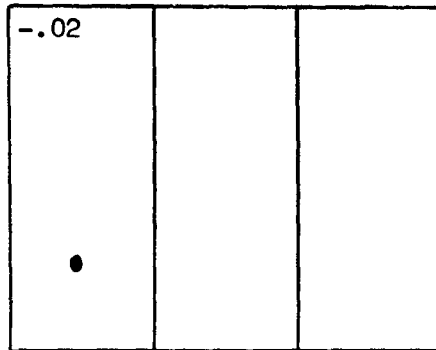
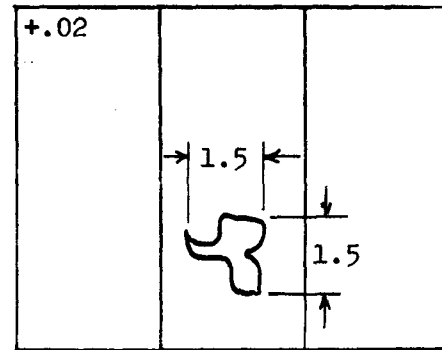
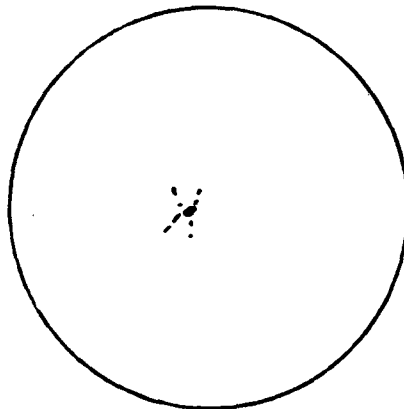
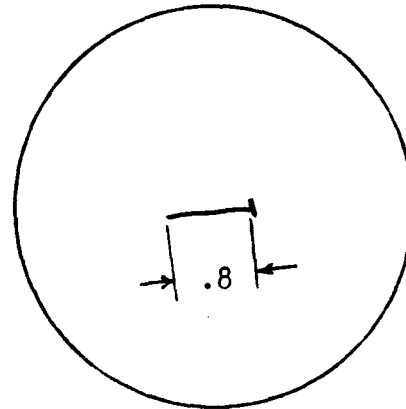
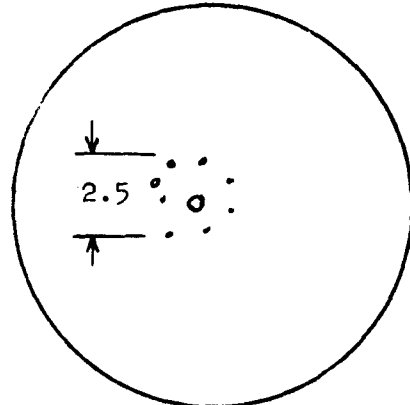
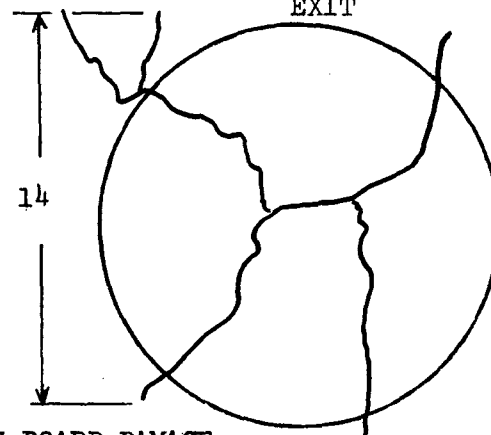
BLOCK NUMBER B 1  
 ROUND NUMBER T 23

The projectile entered straight but exited 3/4 to full tumbled. The skin cored both entrance and exit. Backing board was cored on entrance and splattered with shrapnel from skin. The exit backing board was destroyed giving no support at all to the self-sealing material. The self-sealing material suffered little damage on the entrance with a good seal. The exit did not seal with 2 psig pressure or with 0 pressure. It is thought to be because of lack of support between it and the skin because no coring was evident. Upon inspection, the sealant material was found against the exit skin. A hole shows evidence of trying to seal off the leakage.

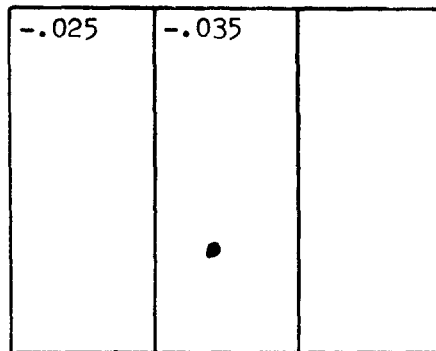
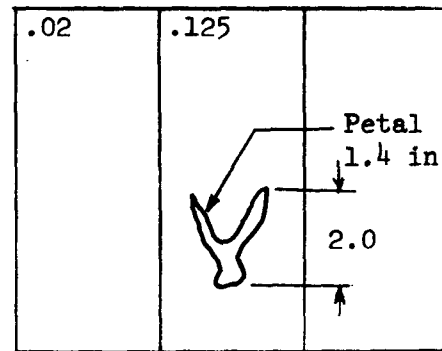
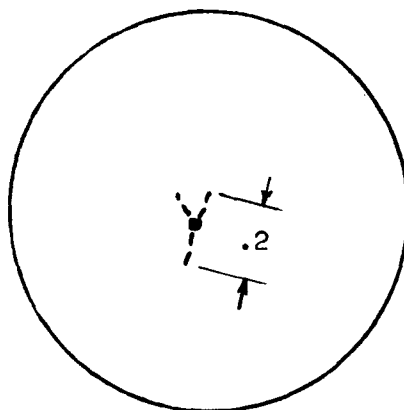
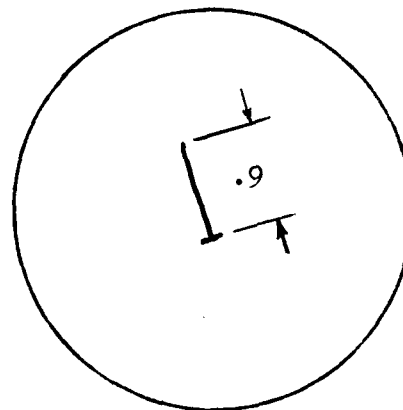
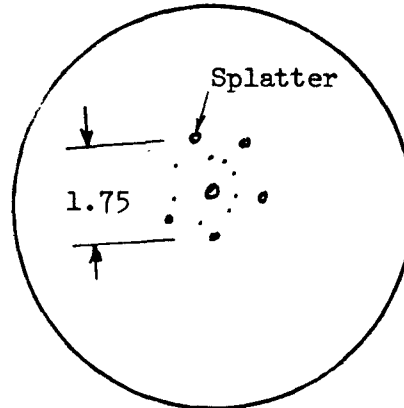
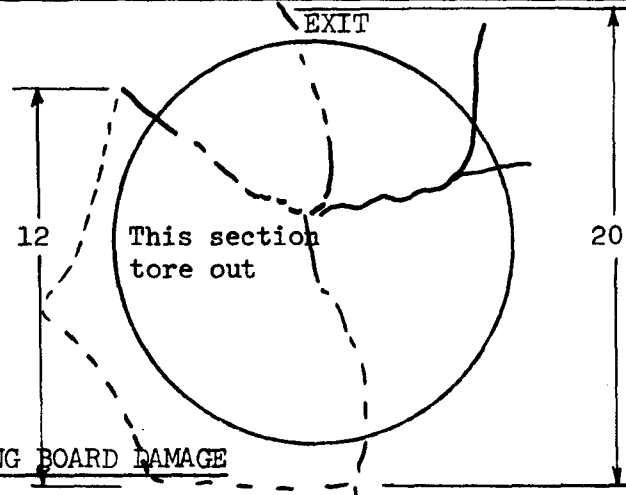
BLOCK NUMBER B 1  
 ROUND NUMBER T 24

The entrance backing board was cored .3 diameter but the exit board was totally failed--torn from top to bottom and cored at the projectile impact point.

The self-sealing material suffered little damage on the entrance but was cut 1.10 inches long on the exit. The back side (away from the fuel) was frayed some and did not seal.

Leakage rate was approximately 3 gal/min constant.

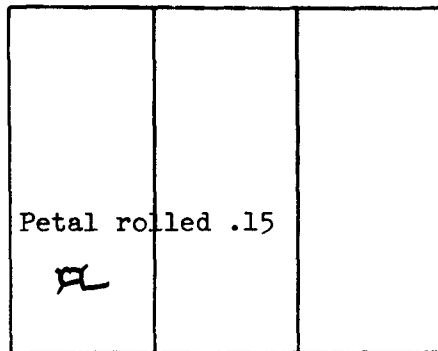
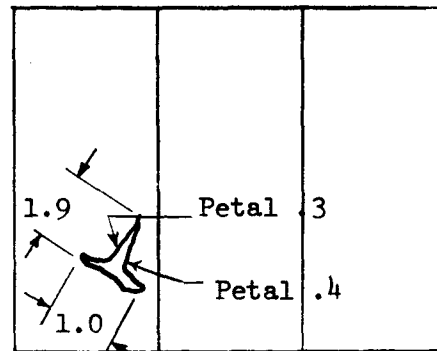
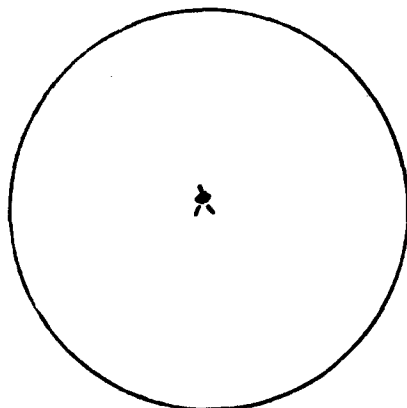
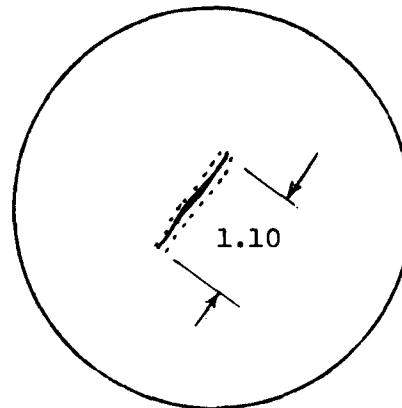
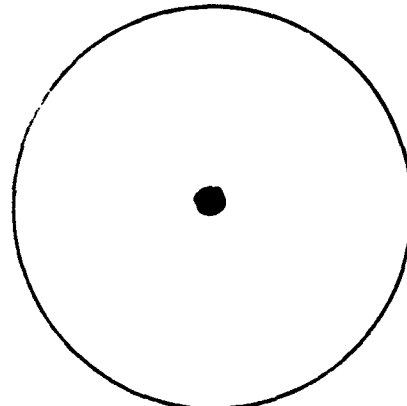
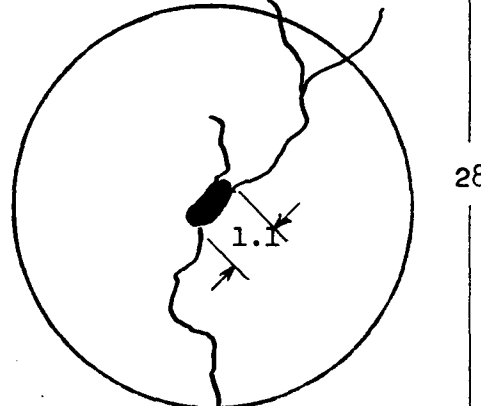
BLOCK NUMBER B 5  
 ROUND NUMBER T 25

The projectile entered straight, coring the skin and creating a .2 in. high petal and fraying the backing board. The self-sealing material leaked enough to wet the surface but did not drip any. The wound on the entrance was cracked some but no coring was present. The projectile exit was fully tumbled. The projectile did not puncture the skin but did dent it. The backing board was split out giving no support to the sealing material. The sealing material suffered a 1.25 inch split with cracking. The self sealant was not activated thus no seal was obtained. The leakage rate was 1.2 to 1.35 gal/min constant rate.

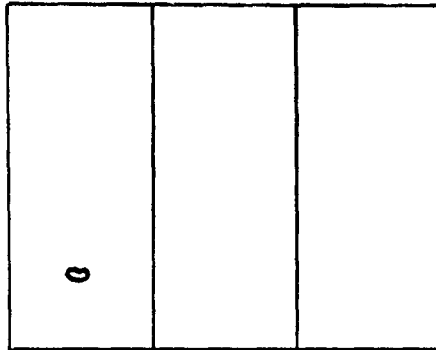
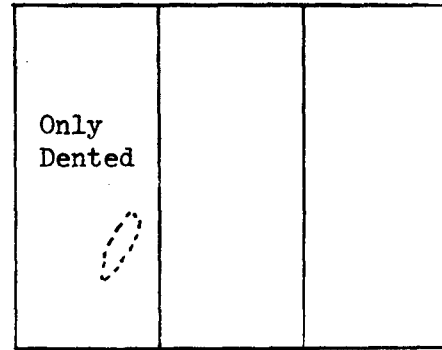
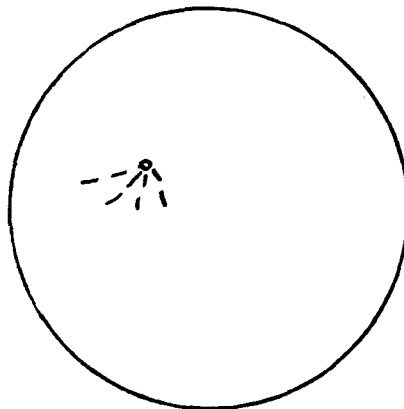
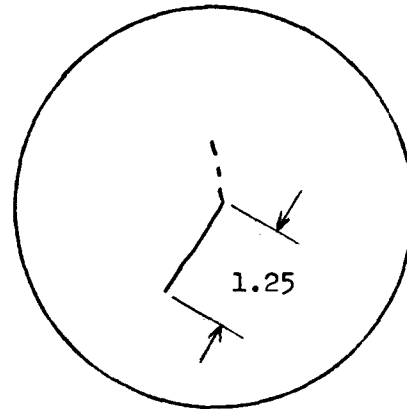
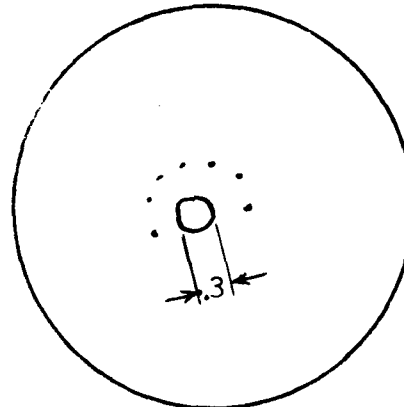
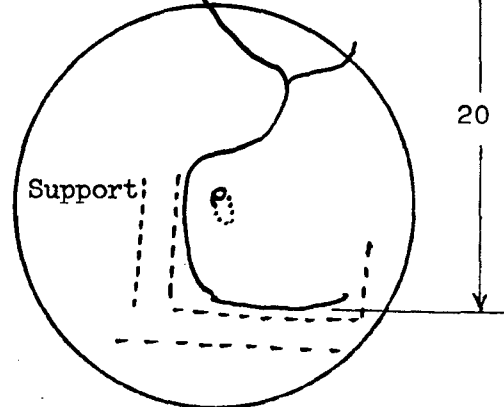
BLOCK NUMBER B 3  
ROUND NUMBER T 26

The skin was not penetrated but was dented size of tumbled round. The backing board was split to total failure - no support. Self-sealing material seeped but no drips occurred until pressurized. At 2 psi pressure the leakage rate was constant at 96 drops/minute. At 0 pressure the wound would dry up to a dry seal.

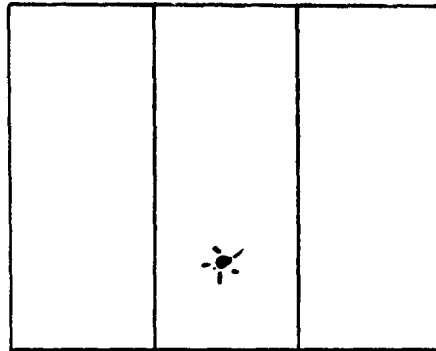
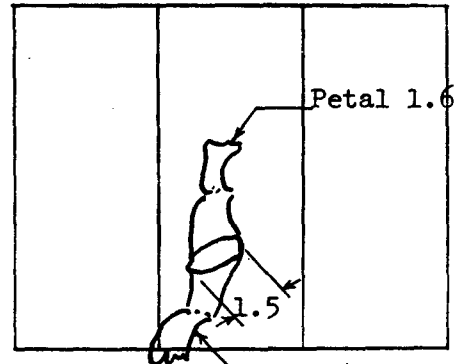
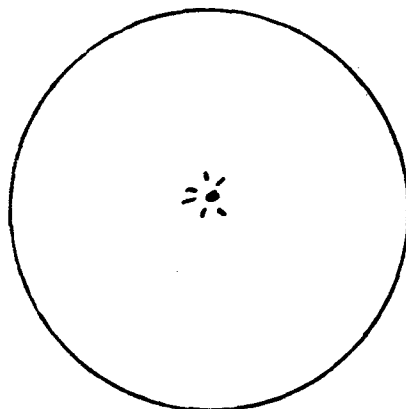
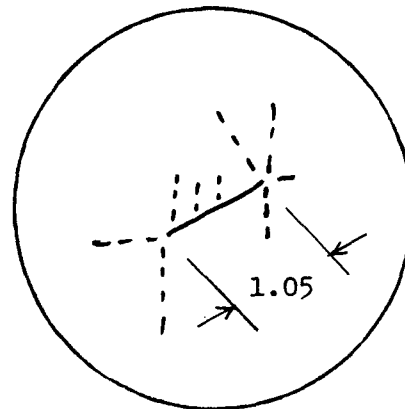
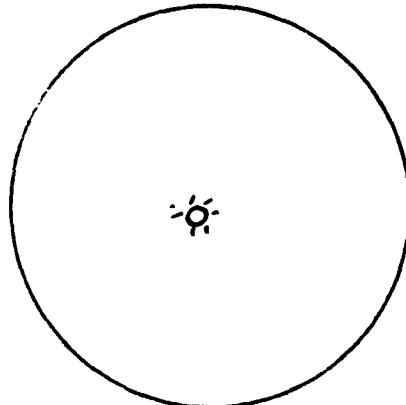
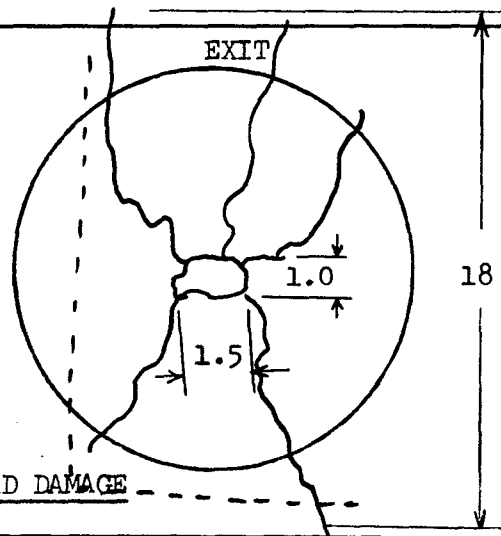
ROUND NUMBER T 28

The projectile entered straight, **coring** and petaling the skin. The backing board was also cored but the self-sealing material held with no visible leakage. The exit wound was from the projectile being fully tumbled. The skin was petaled and cored. The backing board was frayed such that no support was left for the self-sealing material wound. The self-sealing material suffered a slit with cracking. No support was available so the wound leaked at a rate of 175 ml/min (0 press) constant. When given support with the edge of a 6-inch scale the wound would seal to a drip rate. When pressurized the wound would flow full force.

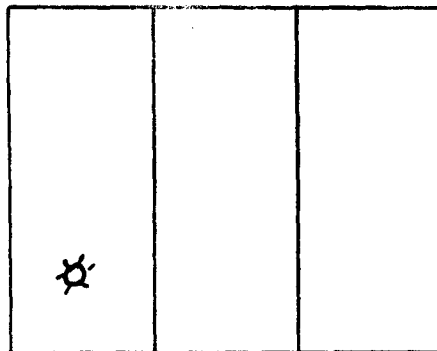
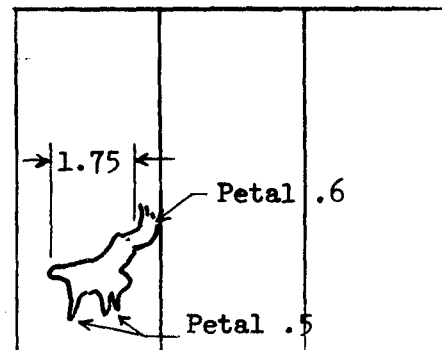
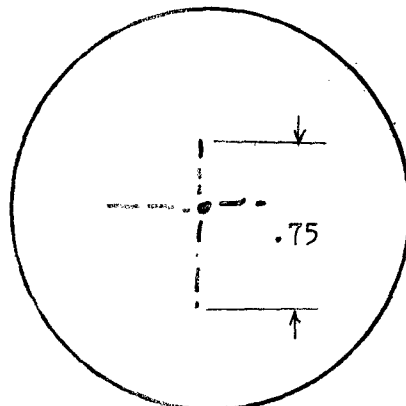
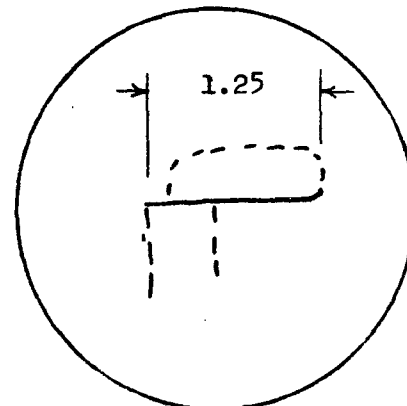
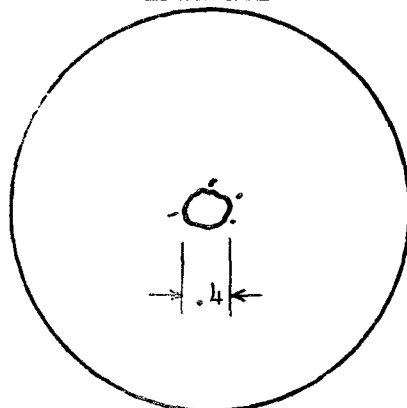
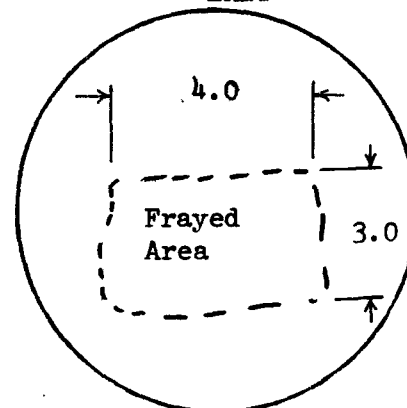
ROUND NUMBER T 29

The skin and backing board were cored. The self-sealing material looked like it did not seal. The entrance caught fire upon impact. The lower clamps on the end frame then failed and fuel started escaping, thus the whole specimen was soon covered with fire. The self-sealing material was pulled into the box so sealing at the lower edge was impossible.

Cored skin and high petaling was evident. There were no measurements because of fire. On disassembly, the self-sealing material suffered a blister from burning approximately 4 inches wide and 8 inches high. Looked as if some leakage occurred at the exit wound also.

The foam in the box was burned at the vent and manometer connections. (2 inch pipes) The vent was open and the foam was burned 2 inches diameter 2 inches deep. At the manometer connection it was burned approximately the same but the foam was still intact. Also, the foam was charred on one side where the box was the hottest. The fire department arrived on the scene and had the fire put out in 6 minutes after the gun was fired.

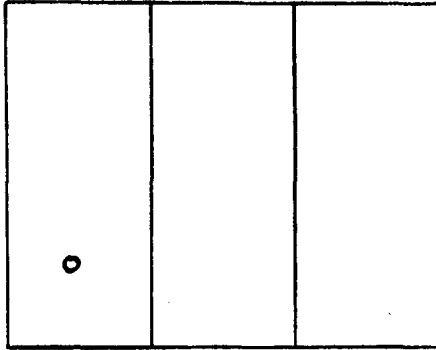
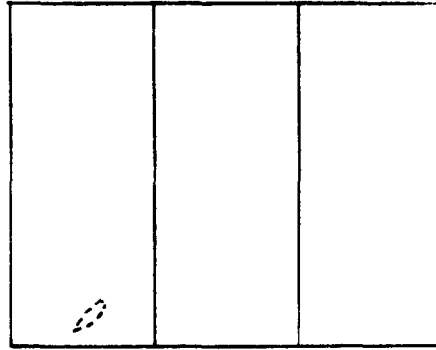
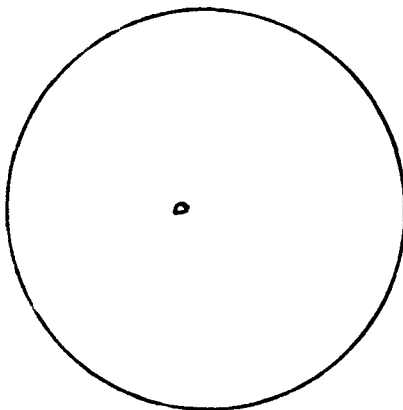
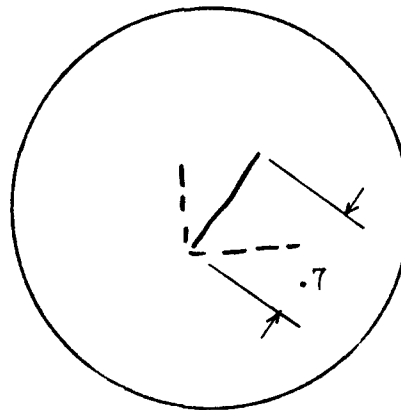
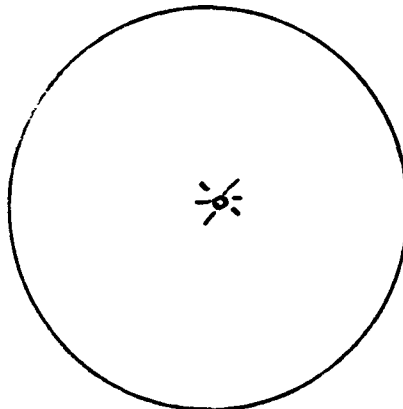
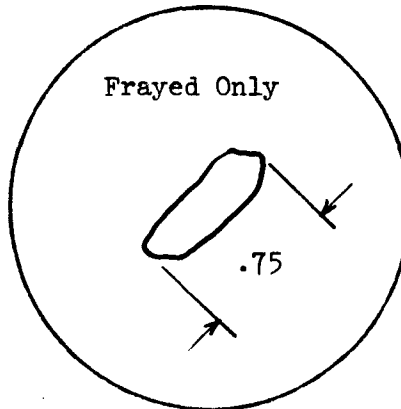
BLOCK NUMBER B 48  
ROUND NUMBER T 32

Projectile struck rib in panel coring it. The self-sealing material sealed with no trace of fuel leakage. Backing board frayed some.

Projectile struck back self-sealing material and marked it but did not cut it. No leakage occurred.

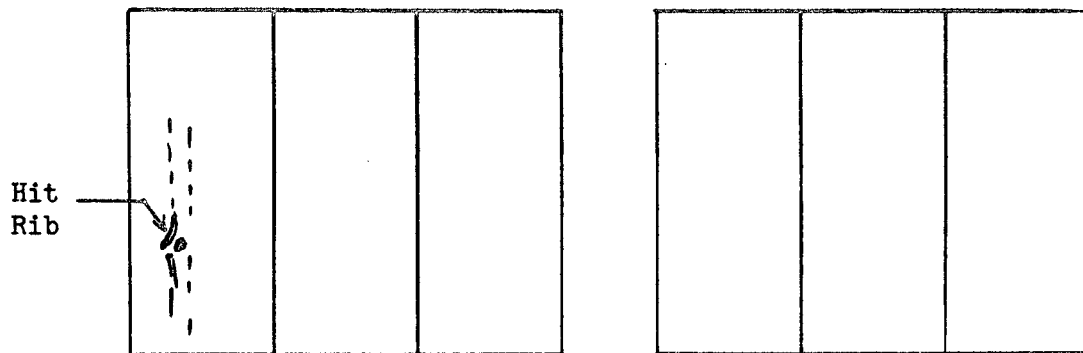
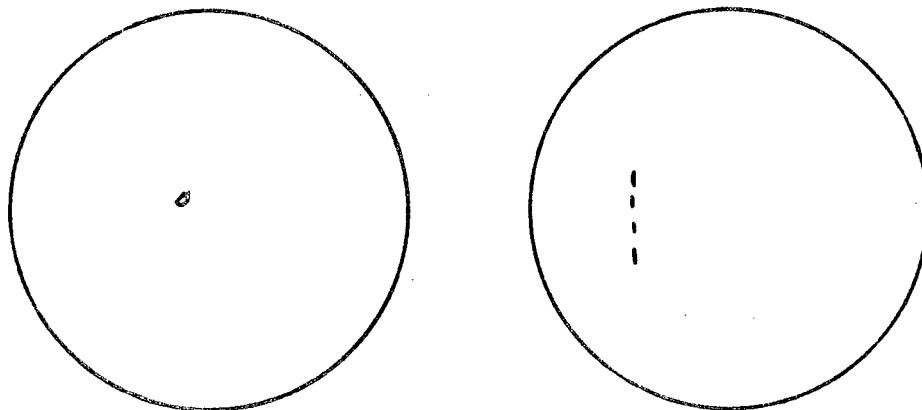
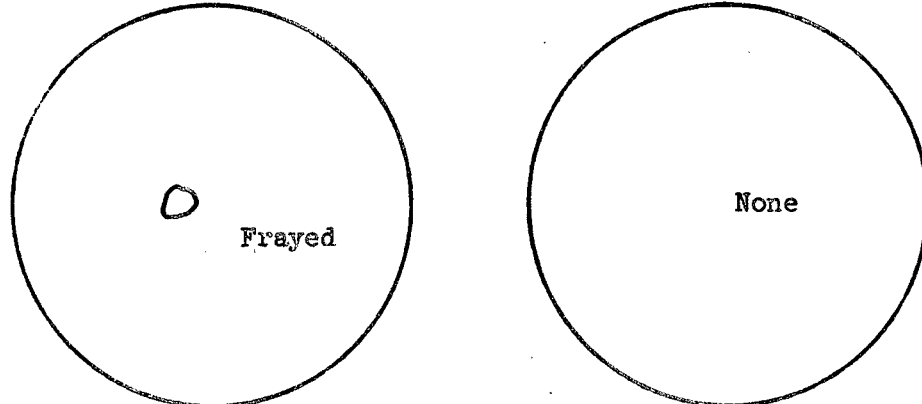
No leakage occurred. After the shot the box was pressurized to 1 psi. No leaks occurred at any of the wounds.

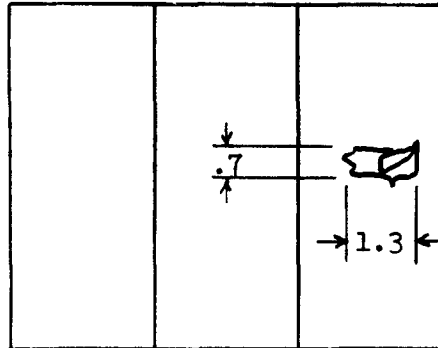
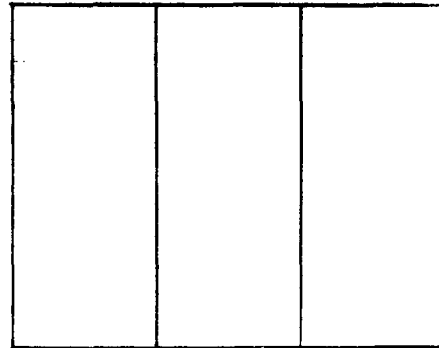
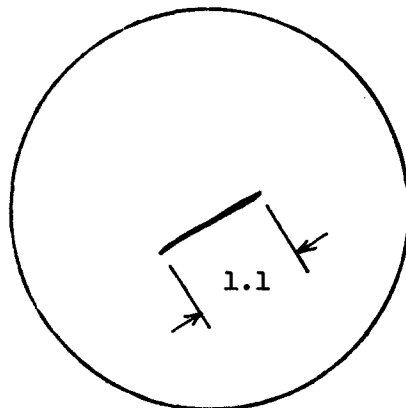
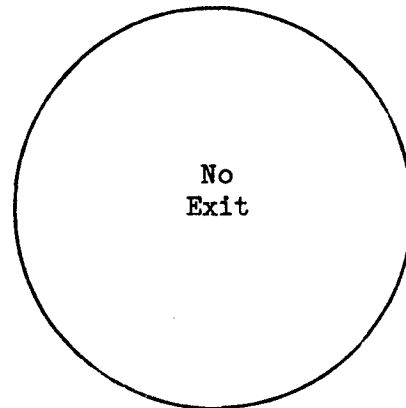
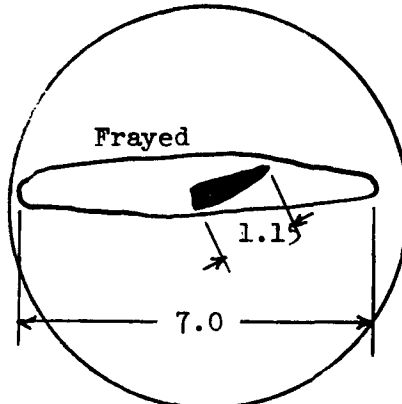
ROUND NUMBER T 34

The backing board frayed and cored the size of the projectile. The self-sealing material sealed dry with no trace of fuel leakage. The skin was cored and petaled.

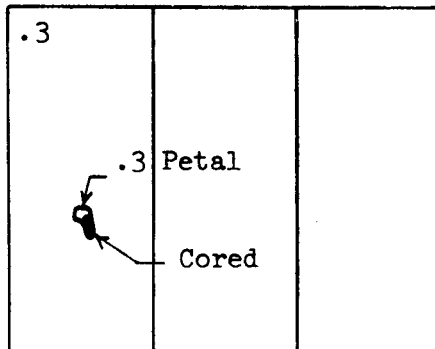
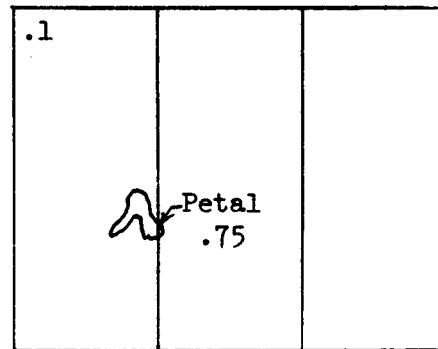
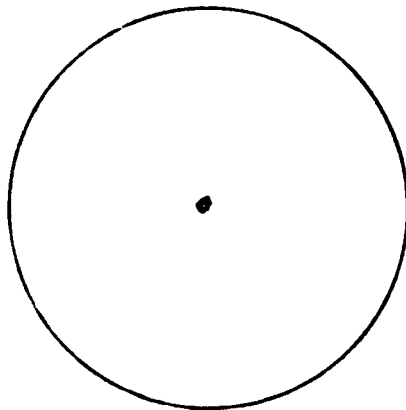
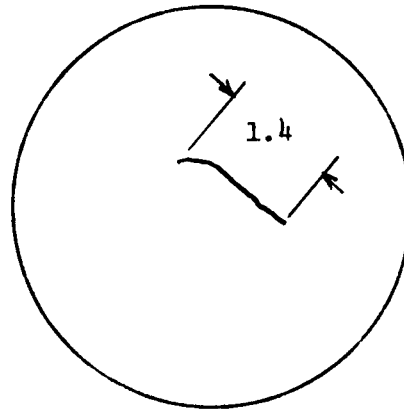
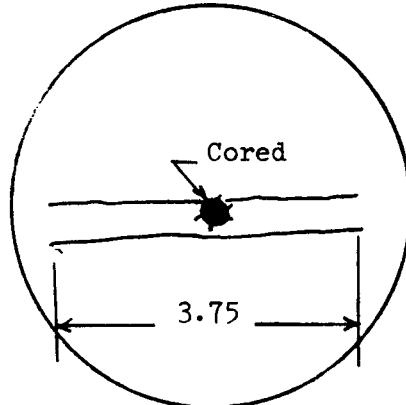
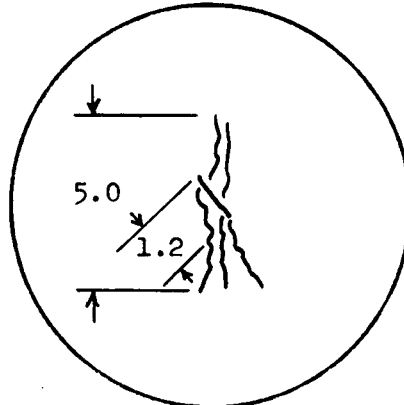
ROUND NUMBER T 35

The backing board was frayed and cored badly. The self-sealing material was also cored and pulled loose from the skin. The skin was petaled .7 inches, cored and split. Ribs on the skin sheared the rivets and warped. The skin had very little strength left. Leakage was constant (full flow) with no slowing; thus failure.

The projectile struck a wood support and only the nose pierced the skin. The backing board was frayed and cored slightly. The self-sealing material sealed with no visible leakage. Therefore, entrance material failed; exit material passed.

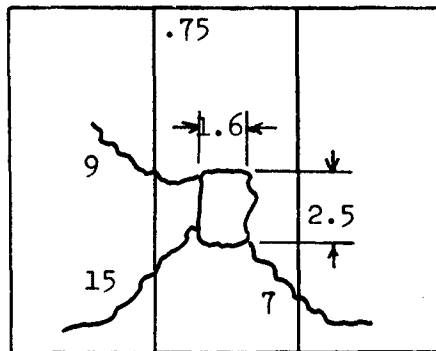
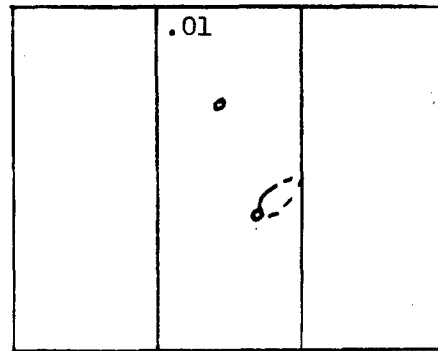
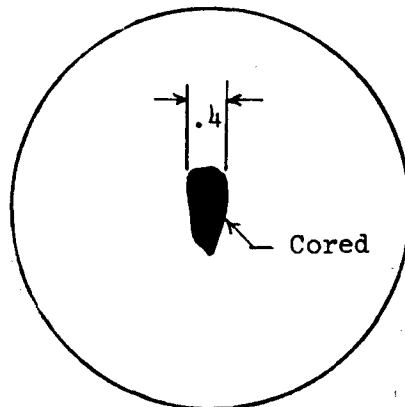
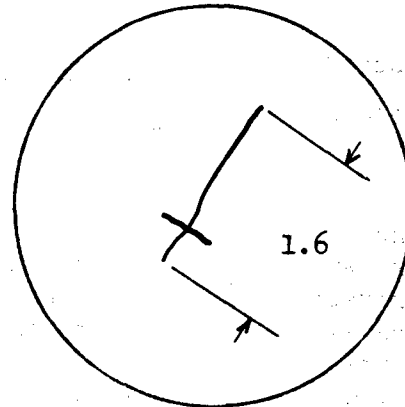
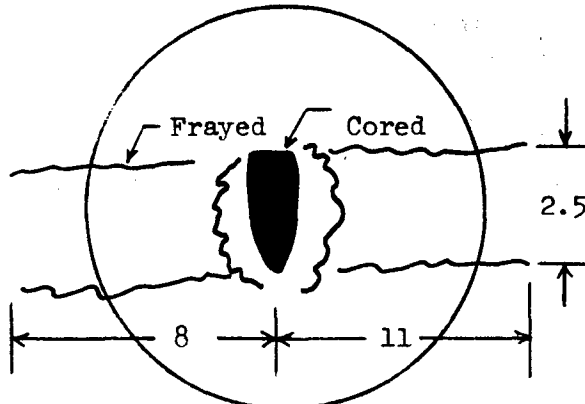
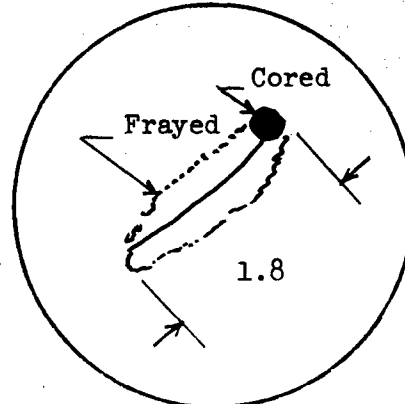
ROUND NUMBER T 36

A flash was seen at the entrance approximately 8 inches diameter and for approximately 1/2 second. A burn was also noted on the skin and backing board. The skin was cored and had a .3 inch petal. The backing board was frayed to the size of the projectile. The self-sealing material was cracked on the inside but did not leak even a trace of fuel.

The skin was cored and petaled to a 1.2 inch maximum height. The backing board was torn and frayed over an area 6 inches x 9 inches but not cored. The self-sealing material was frayed on the exit side considerably. When the material was straightened back out the self-sealant did bond together. It was determined that it would not hold, though, with the backing board support destroyed. Leakage rate was unable to determine.

Failure on exit due to no support and material pulling into fuel tank.

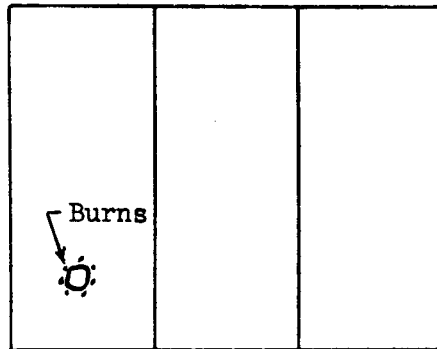
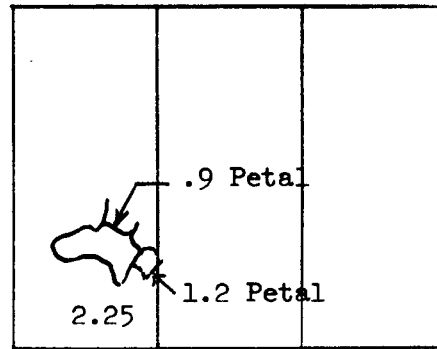
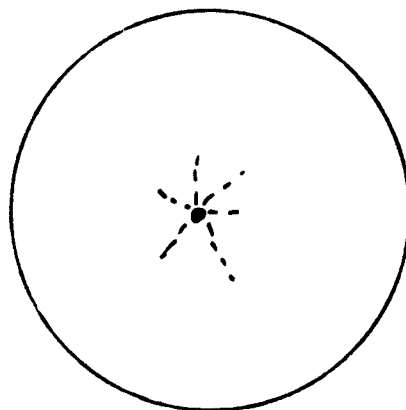
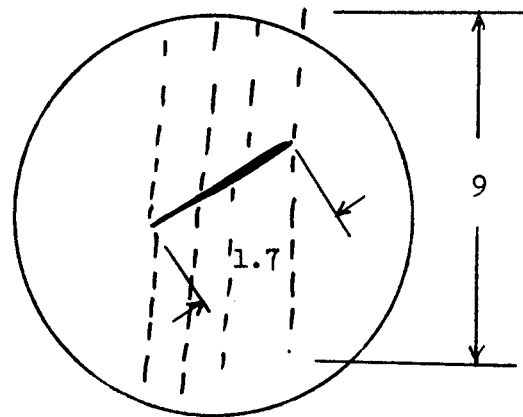
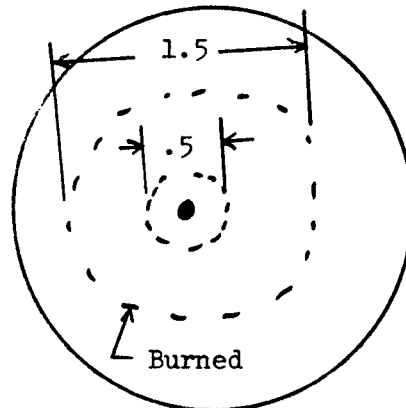
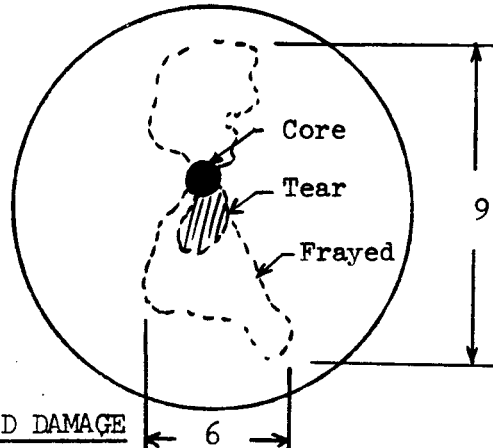
ROUND NUMBER T 37

The skin was petaled outward on 1/2 of hole and inward one 1/2 of hole. Petal height was .15 inches. The skin also cored. A flash was noted on entrance.

Failed skin completely. Petal was 6.5 inches high. The backing board held and the wound in self-sealing material was only damp. Several clamps were knocked off; broke 2 and warped end frame some. The exit flange assembly had to be removed and resealed.

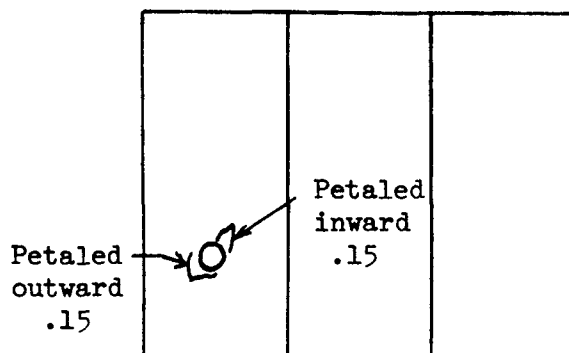
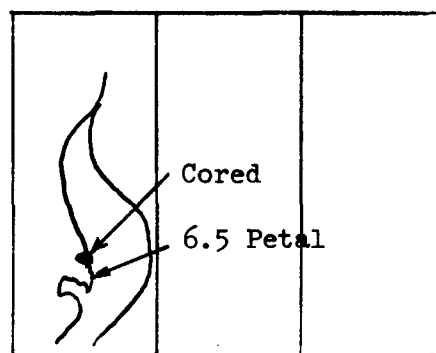
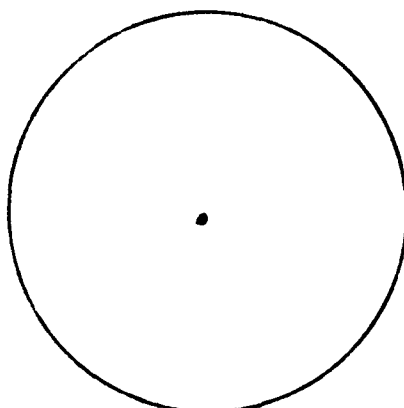
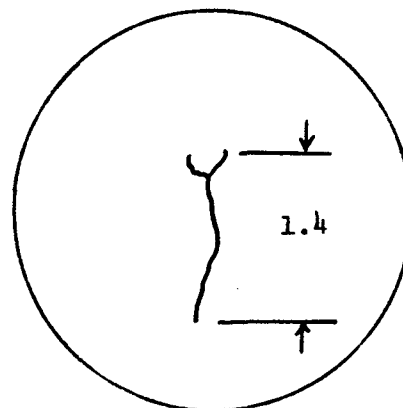
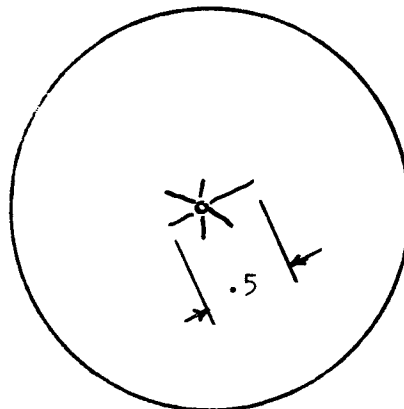
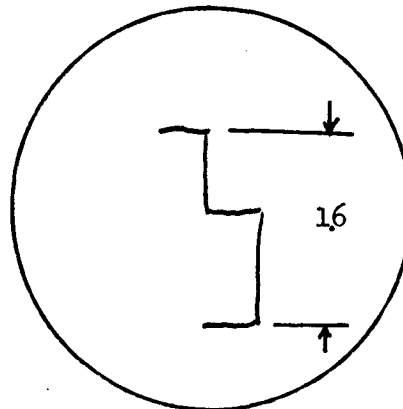
ROUND NUMBER T 38

A large flash was noted on entrance. The skin was cored and petaled slightly (.2 inches). The backing board had almost no damage and the self-sealing material was dry. There was no trace of fuel.

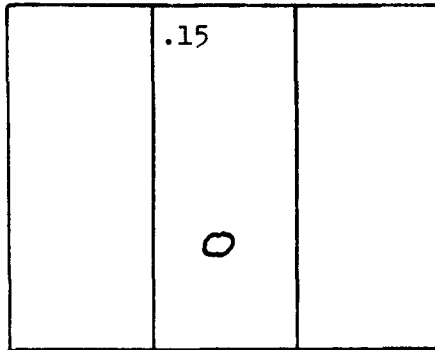
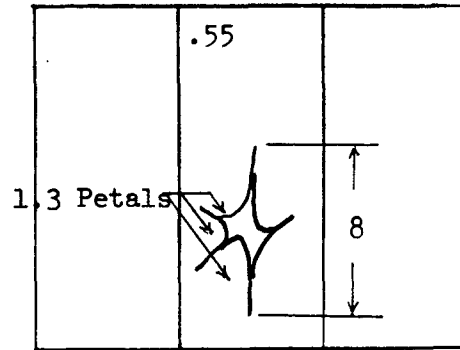
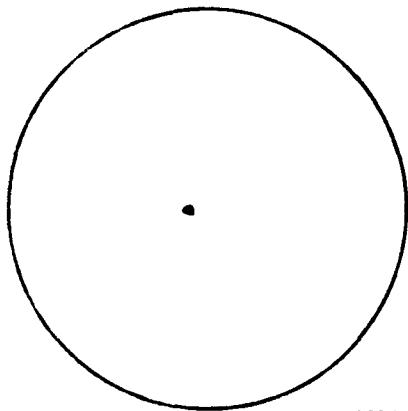
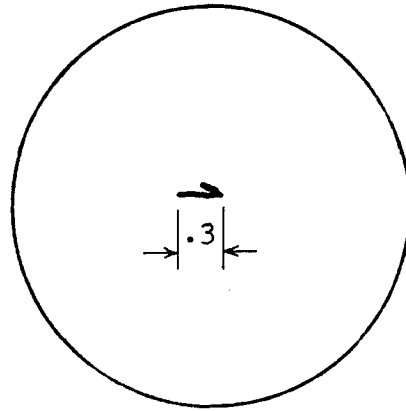
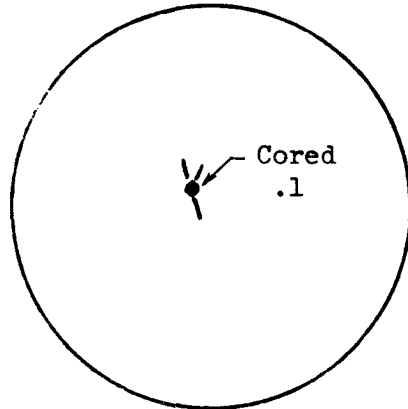
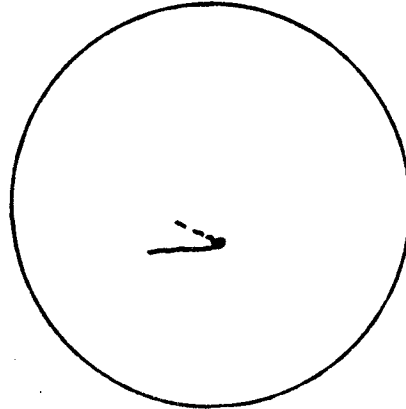
ROUND NUMBER T 39

The skin was cored and split out for a total failure. The backing board did hold and the self-sealing material wound was only damp.

Clamps were broken (9) thus a leakage rate or amount was impossible to get. The self-sealing material was not pulled into the box, though. The back flange had to be resealed.

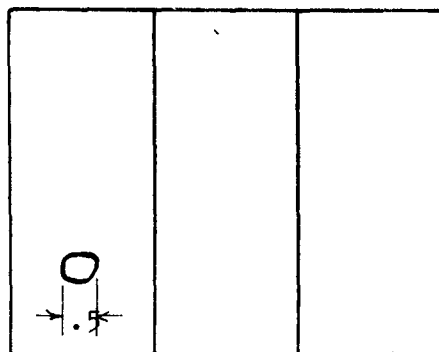
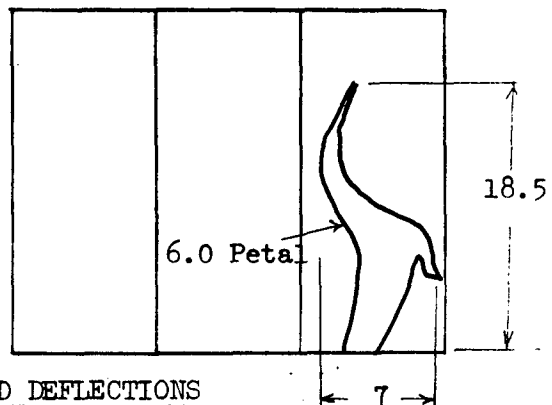
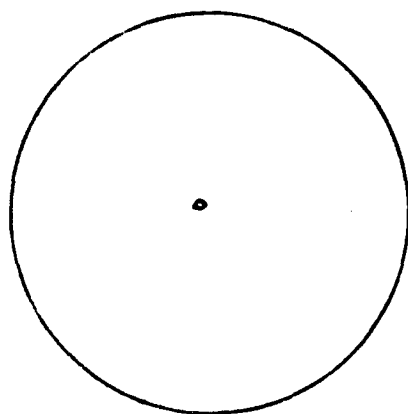
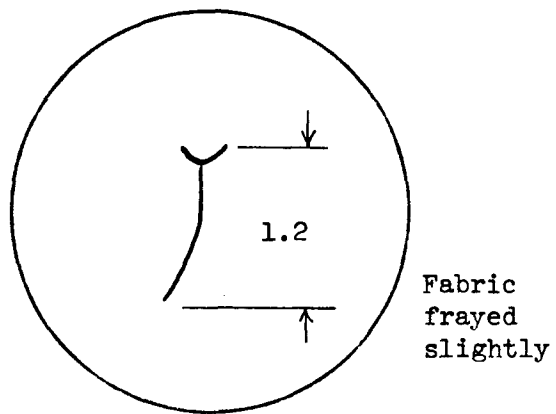
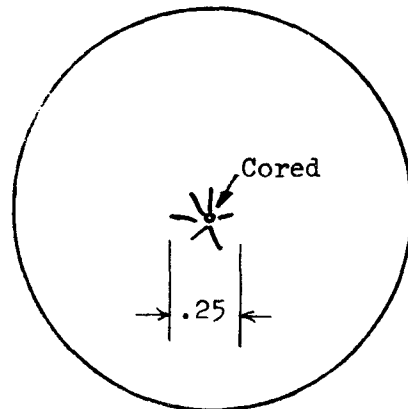
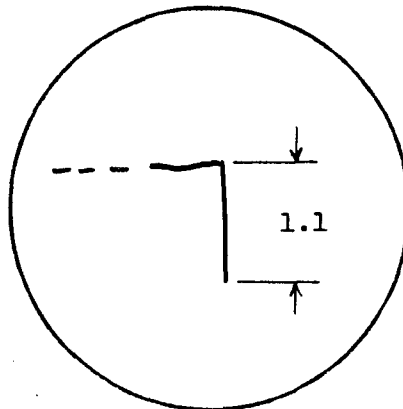
ROUND NUMBER T 40

The skin split into a previous projectile wound (T-39) and was cored. The backing board held and the self-sealing material sealed dry in less than 1 minute. The leakage from the wounds was very slight; mostly just dripping. Several clamps were knocked off and fuel sprayed to the top of the gun butt from the top of the exit flange assembly. Projectile exited at zero velocity.

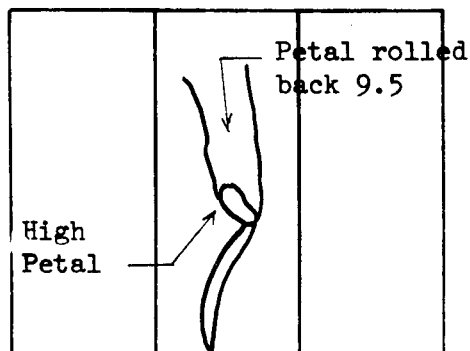
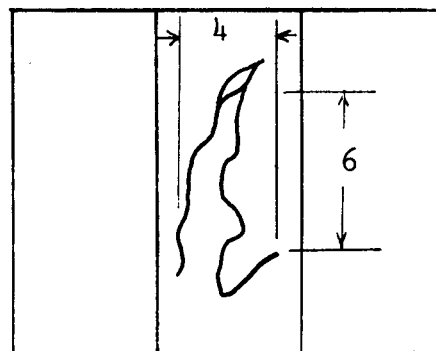
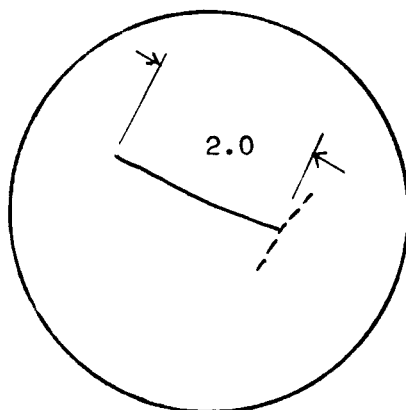
ROUND NUMBER T 41

The skin was split more in T 38 wound and cut by projectile as shown. The backing board held and the self-sealing material had a dry seal in 3 minutes. Leakage was very small and unmeasurable due to leakage around flanges. All wounds bubbled some when pressure was applied for this shot. Exit of T 38 opened up and flowed some fuel. Impact of projectile knocked off the valve Christmas tree and fuel sprayed approximately 12 feet high from the cap. Three threads of a 3/8 tee (alum) were stripped.

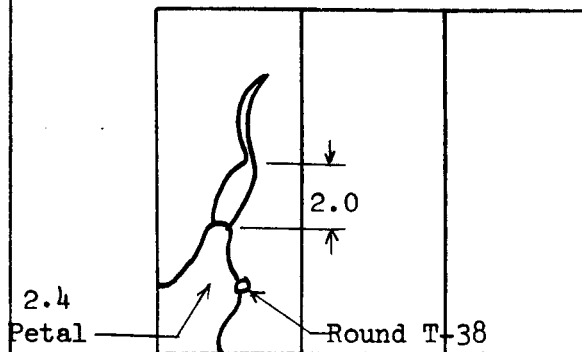
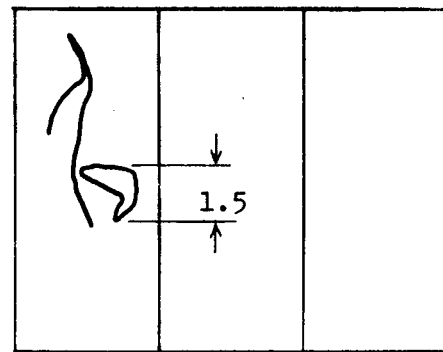
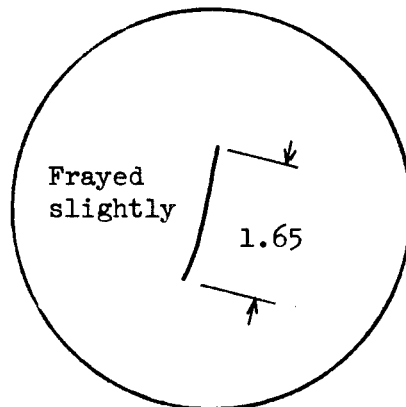
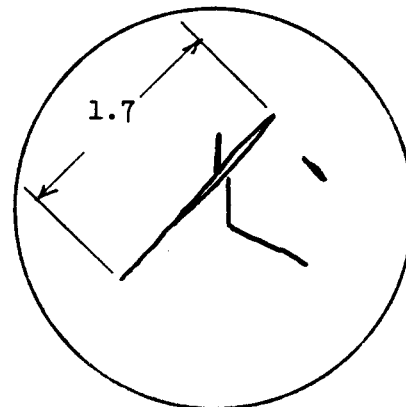
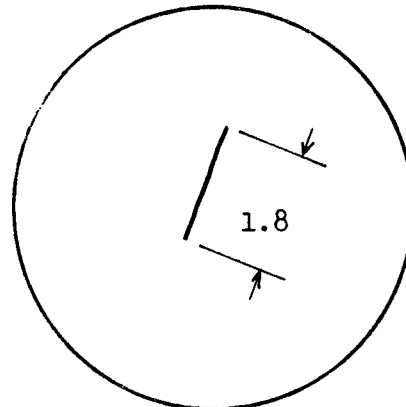
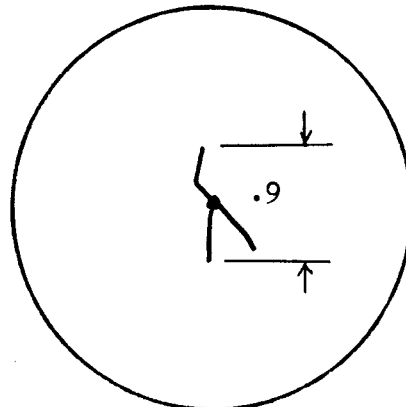
ROUND NUMBER T 42

The backing board was once again frayed considerably larger than the self-sealing wound. The self-sealing material leaked a stream of fuel for 30 seconds, then leaked at a fast dripping rate slowing to 150 drops/minute constant after 3 minutes.
